Monitoring Data Record

Project Title: I-2511CB (I-85 Widening) COE Action ID: 200221534
Stream Name: Town Creek (Site 5) DWQ Number: 040271
City, County and other Location Information: Rowan County, I-85 Widening (-TI-PINC Sta. 20+35)
Date Construction Completed: Water turned on 12/6/06, Stream reforestation completed 12/13/06
Monitoring Year: (4) of 5
Ecoregion: _____ 8 digit HUC unit 03040103
USGS Quad Name and Coordinates: _____

Year 4 Summer – June 2011

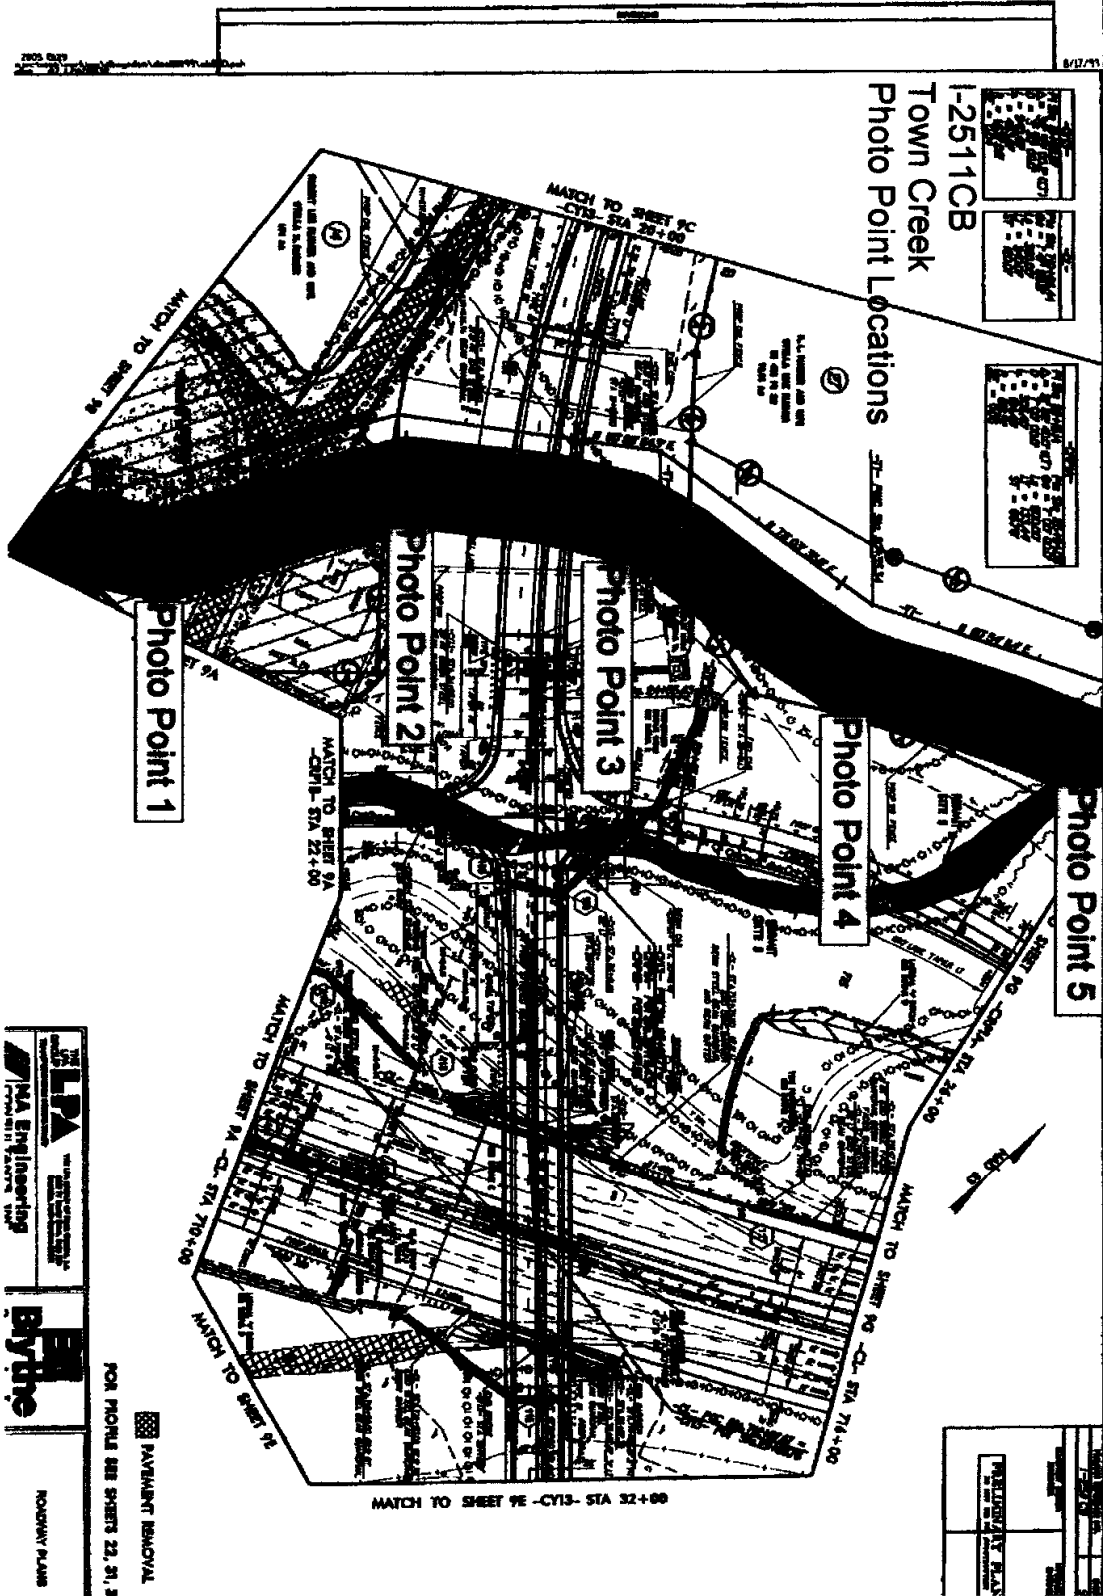
The Town Creek stream relocation is stable for the Year 4 Summer evaluation, except for some bank erosion on the left bank in front of a rock vane at Sta. 16+50 just upstream of the bridge crossing. Some bank erosion was also noted on the right bank at Sta. 13+00 where a drainage ditch exits into the stream relocation. The bank erosion on the right bank at Sta. 13+00 has been noted previously and has seen little or no change since originally noted. NCDOT live staked the eroded areas in March 2010 to help stabilize the banks but the live staking has not stabilized the area.

A site visit was conducted on May 5, 2011 with the regulatory agencies and NCDOT personnel present. It was determined at that meeting that repairs of the left hand bank just upstream of where the bridge crosses was needed. NCDOT plans to use the rock from the rock vane that was installed to construct the toe protection. The bank above the toe protection will be graded at a 3:1 or flatter slope. NCDOT will also plant the repaired area with live stakes during the next planting window (November 15 to March 15). NCDOT will continue to monitor this stream relocation.
